LEC 2014-15 MANAGEMENT PLAN

REPORT

2014-15 LEC MANAGEMENT PLAN STATUS

**LECMP SECTION: AERATION SYSTEM
THROUGH AUGUST 31, 2015**

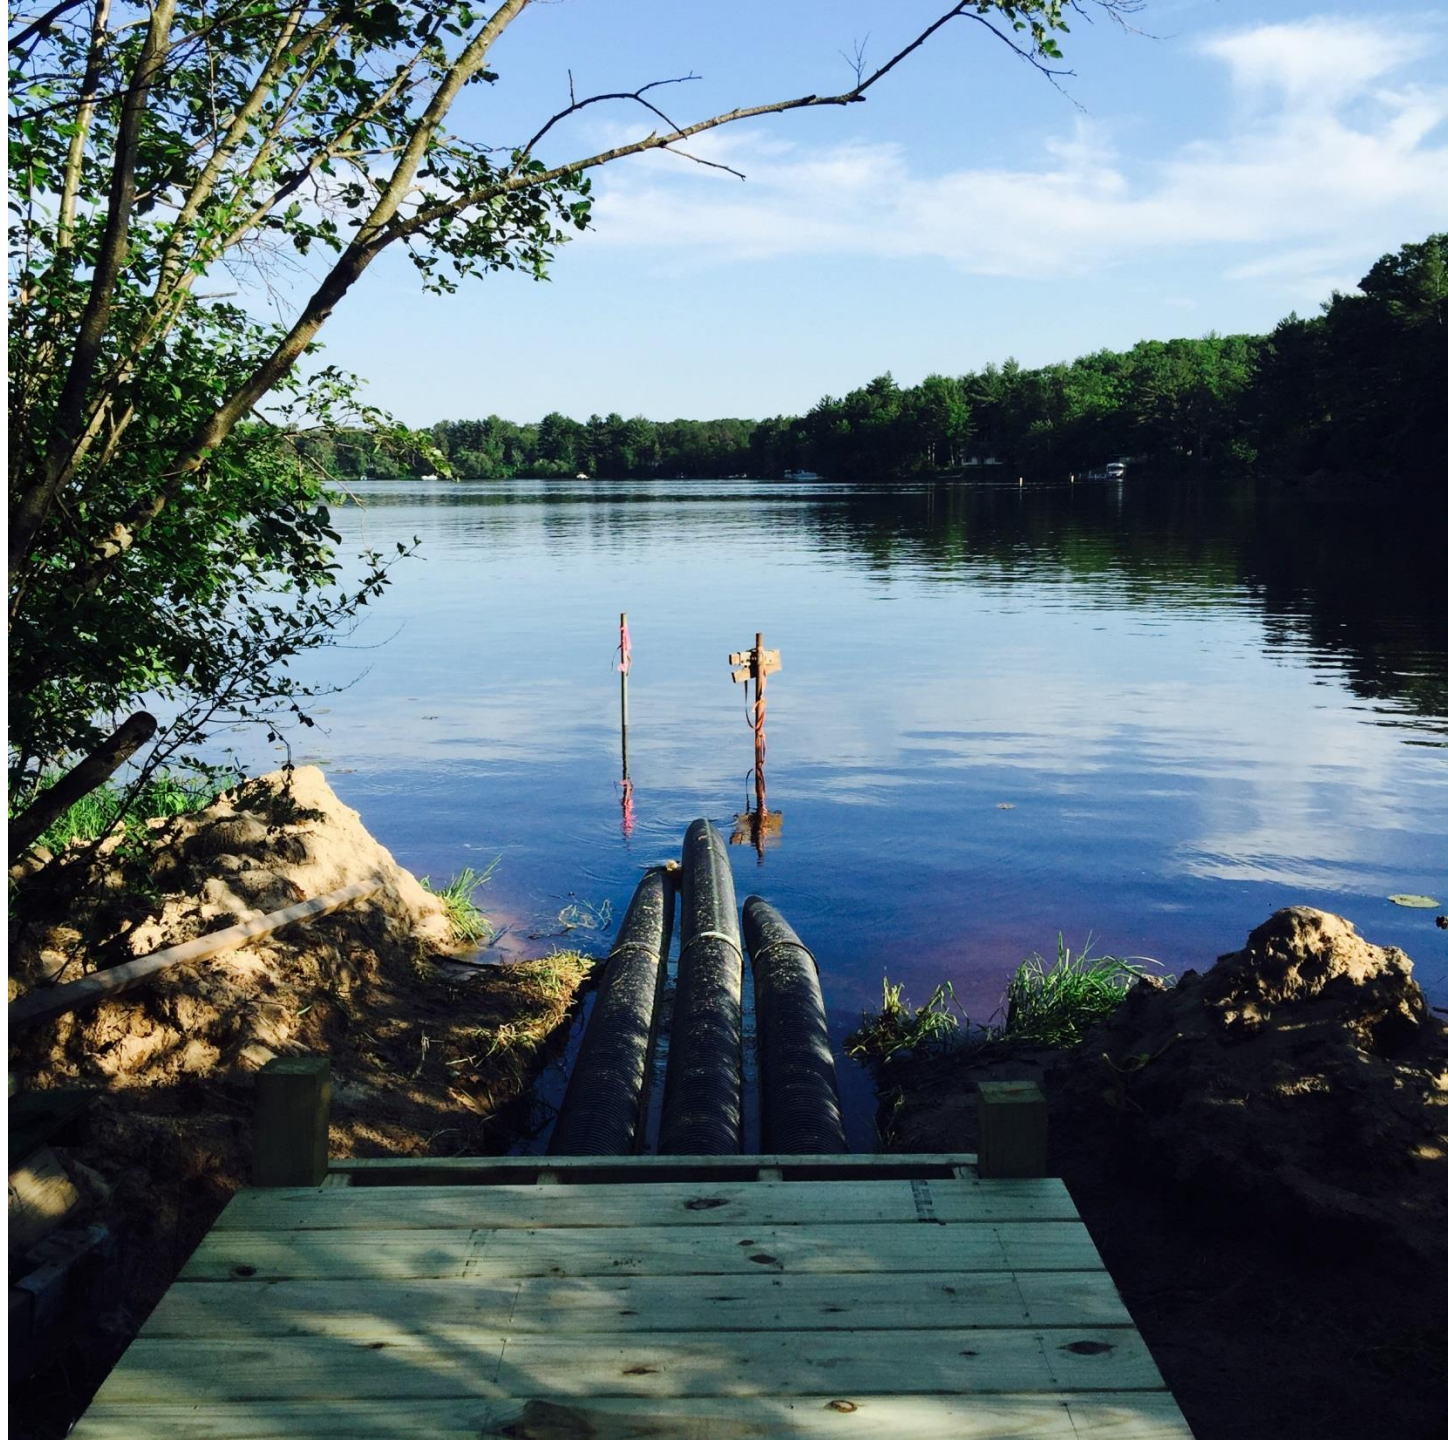
This is a picture of early summer showing end of aeration pipeline. Not shown: During the summer the boardwalk was completed, the pipeline was buried deeper and covered with irregular rip-rap to ice damage to pipeline and boardwalk. GOES developed plans and permits and worked with volunteers to complete the work. Also designed and prepared a dock for installation in spring of 2015.

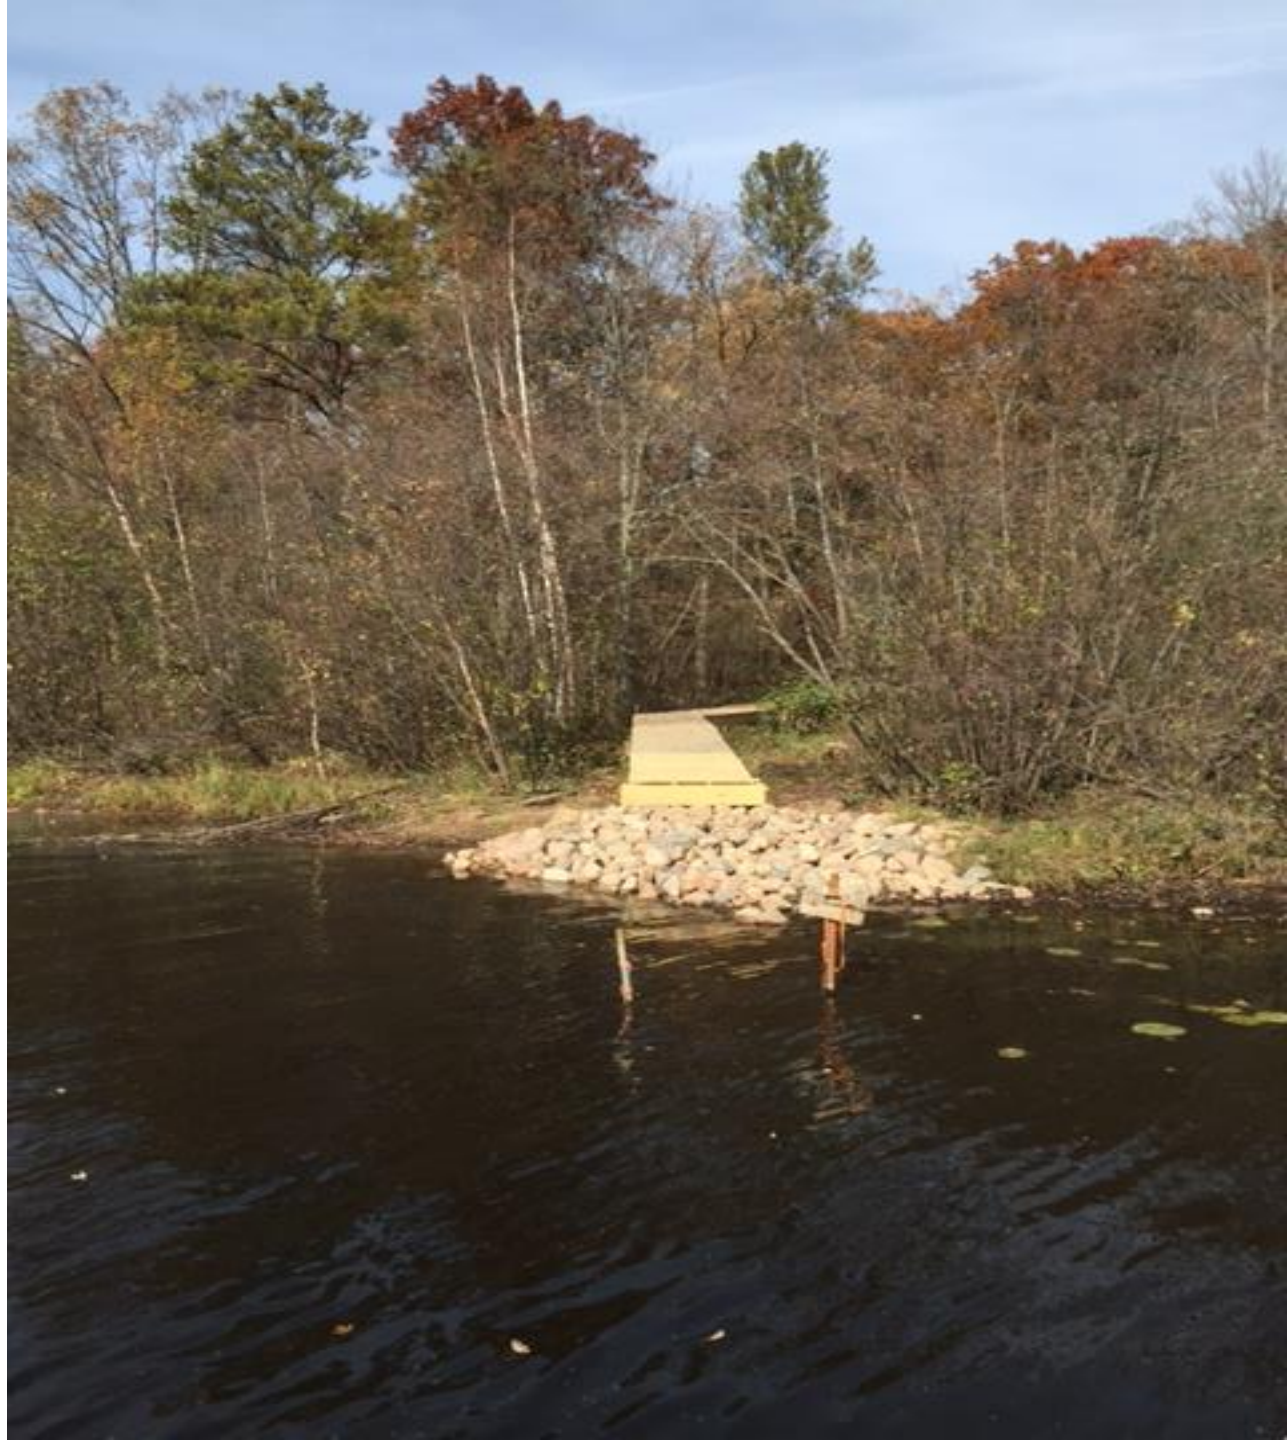
Completed aeration system taken in October 2015. Pipeline was dug down to maximum expected bottom ice level and the 3 x 8" protection conduit were weighed and then covered with rip-rap to protect the pipelines and the raceway from ice and high water damage.

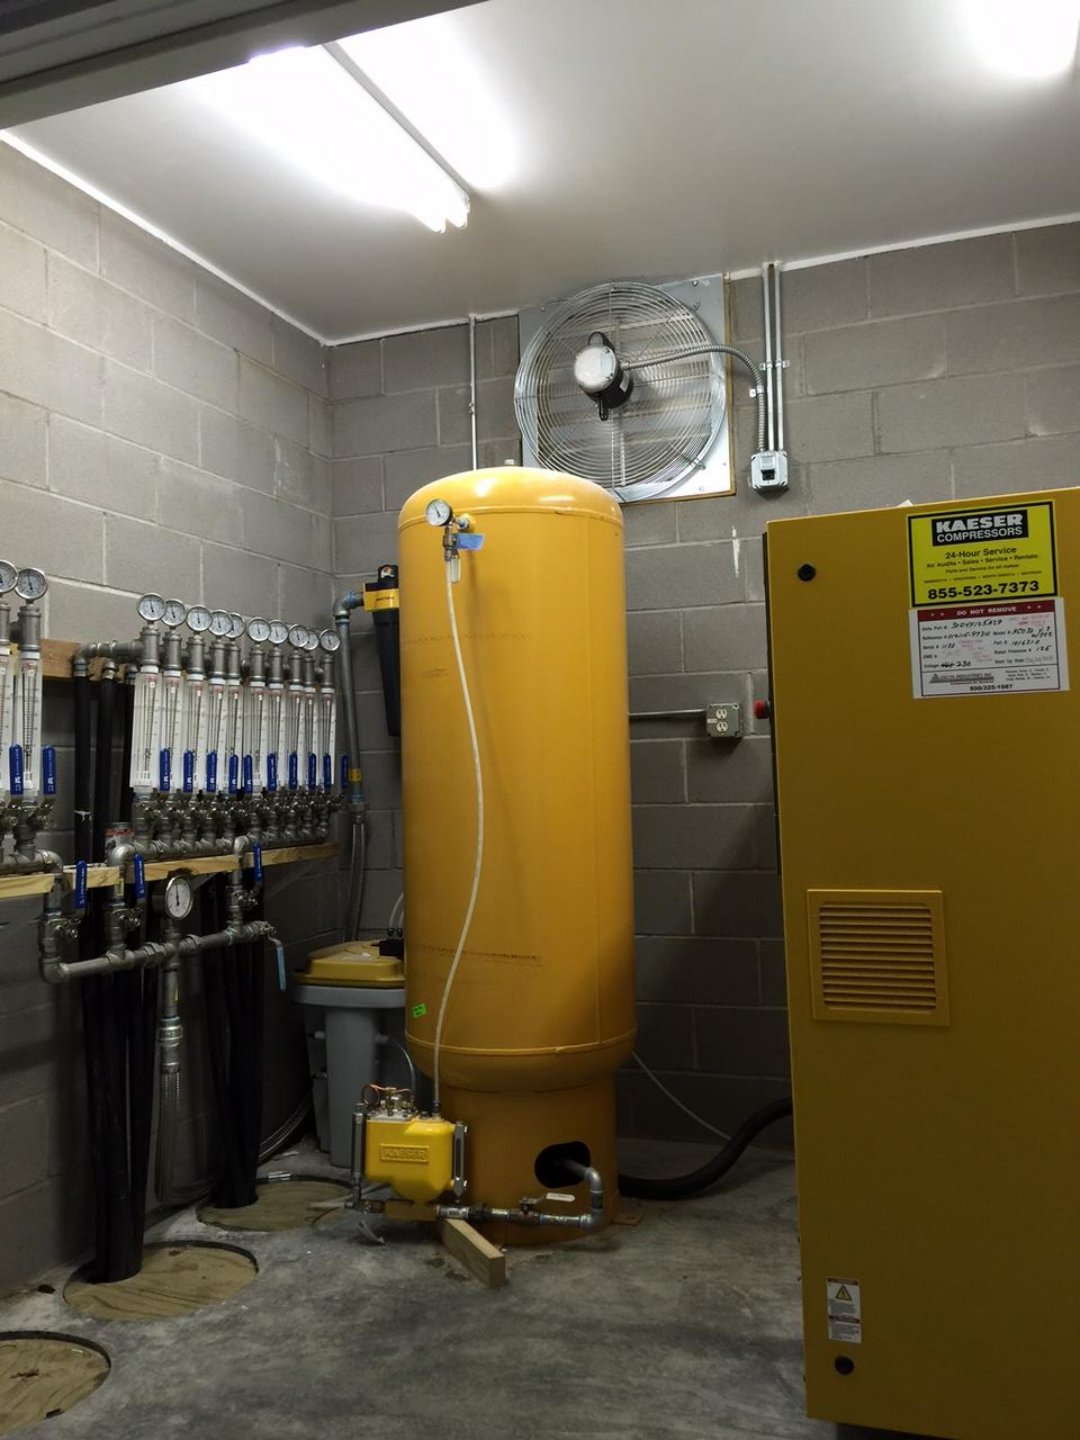
View of the interior of the compressor control room. To the right is the 30hp Kaiser rotary screw compressor. Center is the compressed air ballast tank and air particle and condensation filter. To the left are the 15 air flow calibrated control gages for the lines leading to the individual submerged aeration disks.

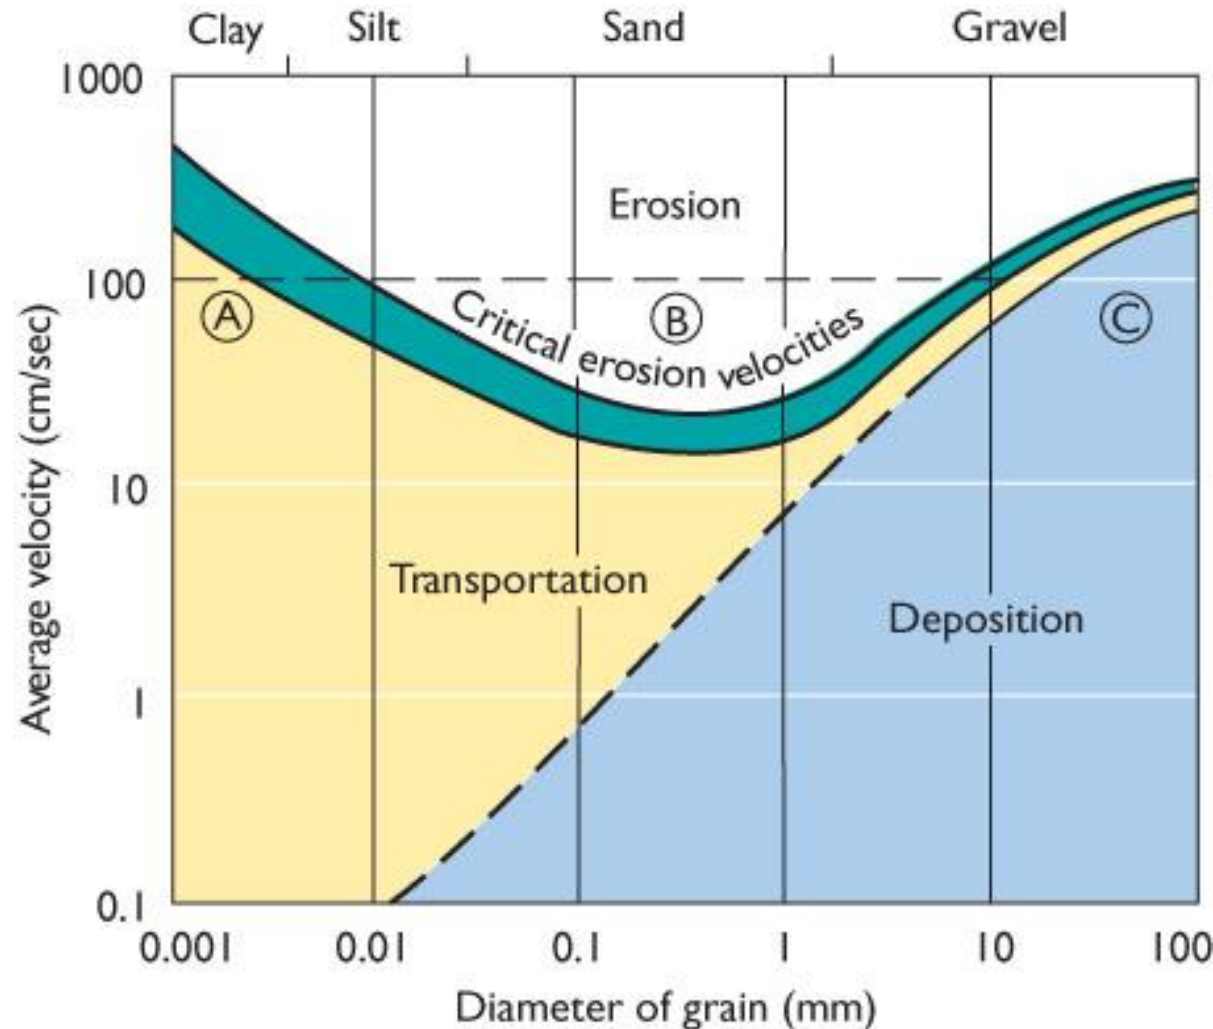
- Hjulström's Diagram graphs the relationship between particle size and energy for

- erosion
- transportation
- deposition

It is important to understand that what Hjulstrom's diagram above predicts is that what the EC River and other LEC sediment traps collect during high water flow is sand, gravel and some cobble. Suspended materials like clay, silt, and fine sand only are deposited when the water flow slows way down as it does when the streams enter the lake. These sediments will deposit throughout the lake and this deposition rate has never been accurately measured for LEC.

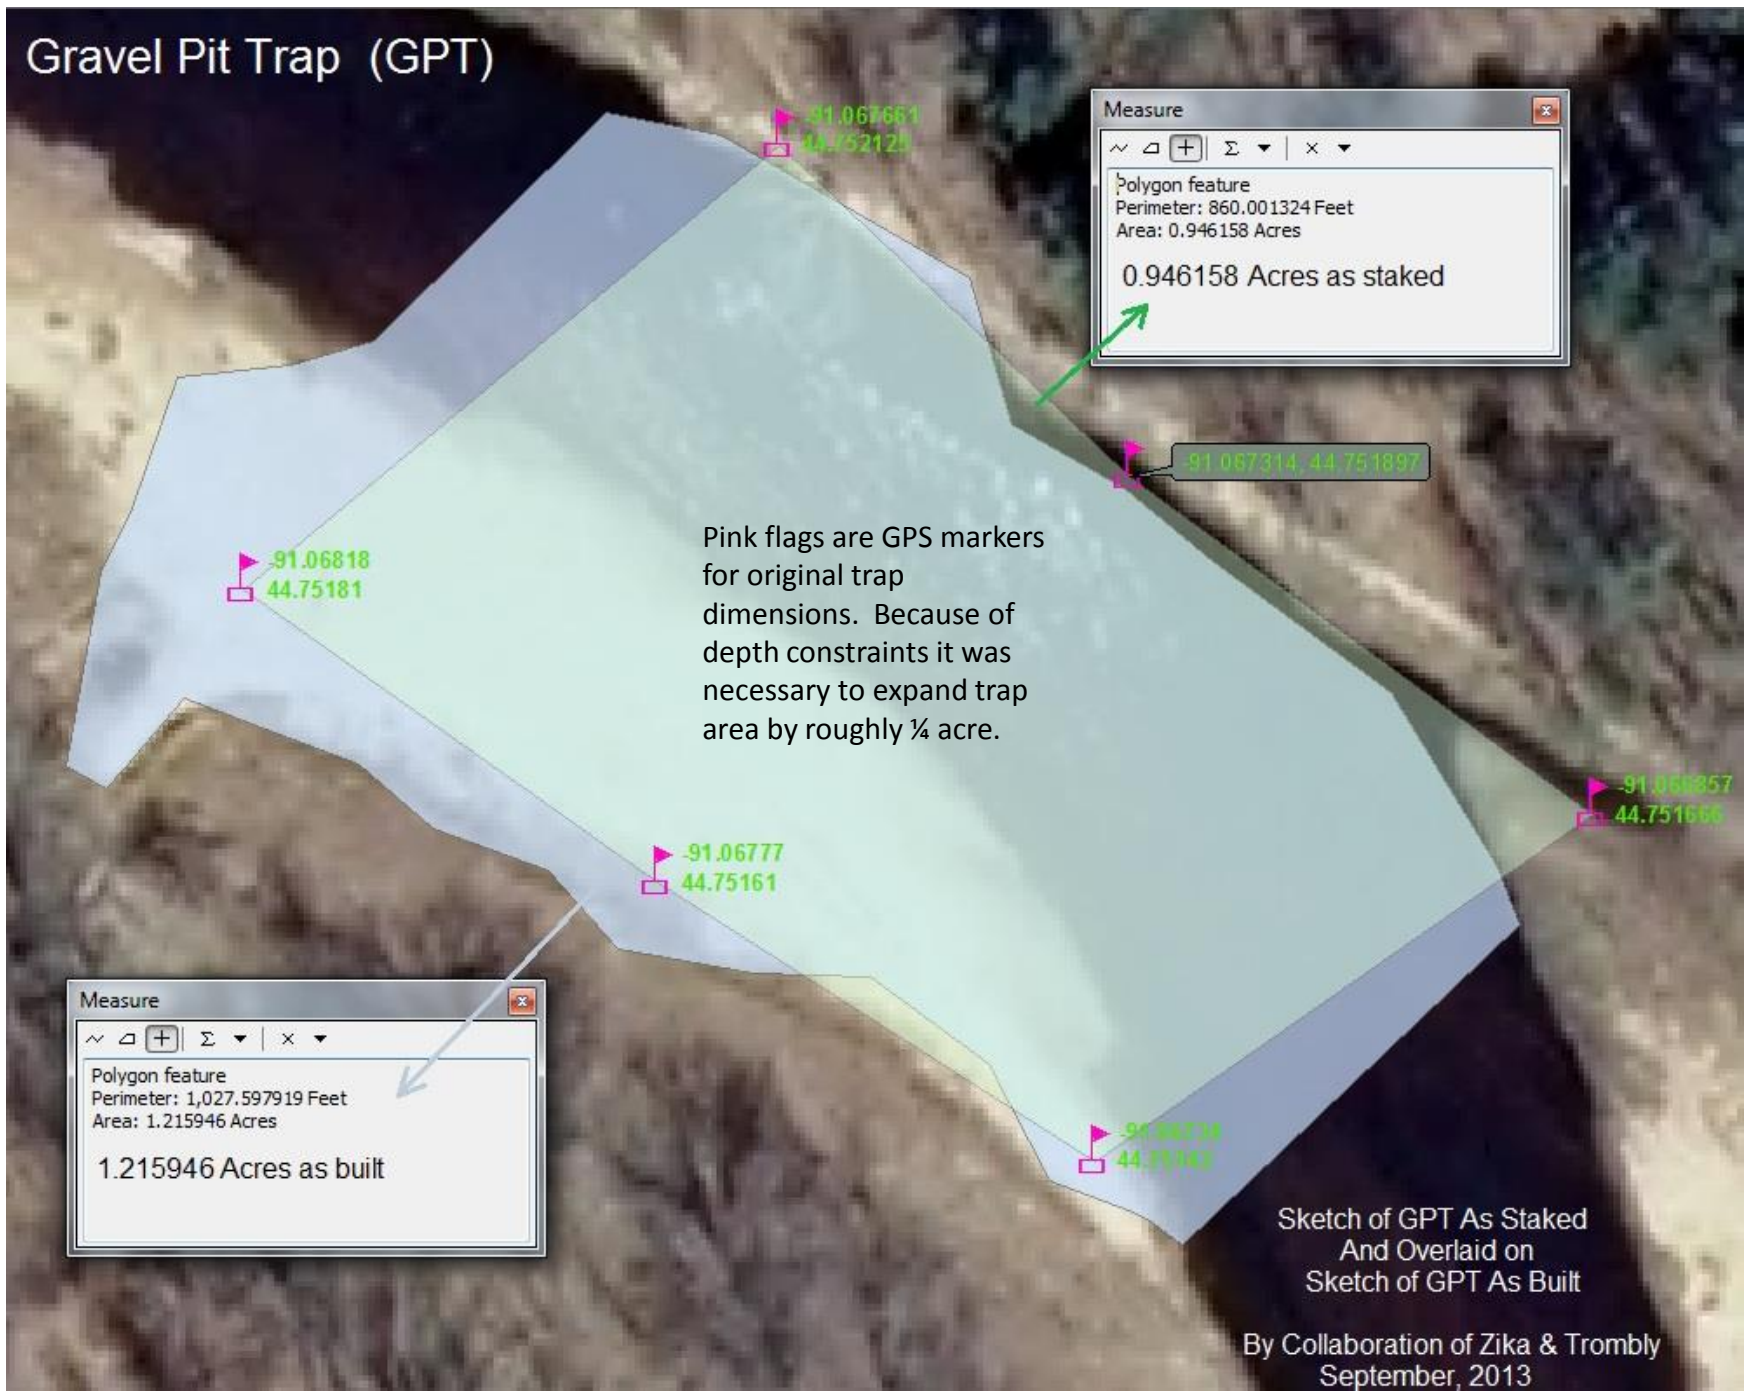
Gravel Pit Trap (GPT)

Bathymetry Graphic of the Gravel Pit Trap on the Eau Claire River.

River was 1.6 feet below normal stage when this data was collected on 8/27/2013

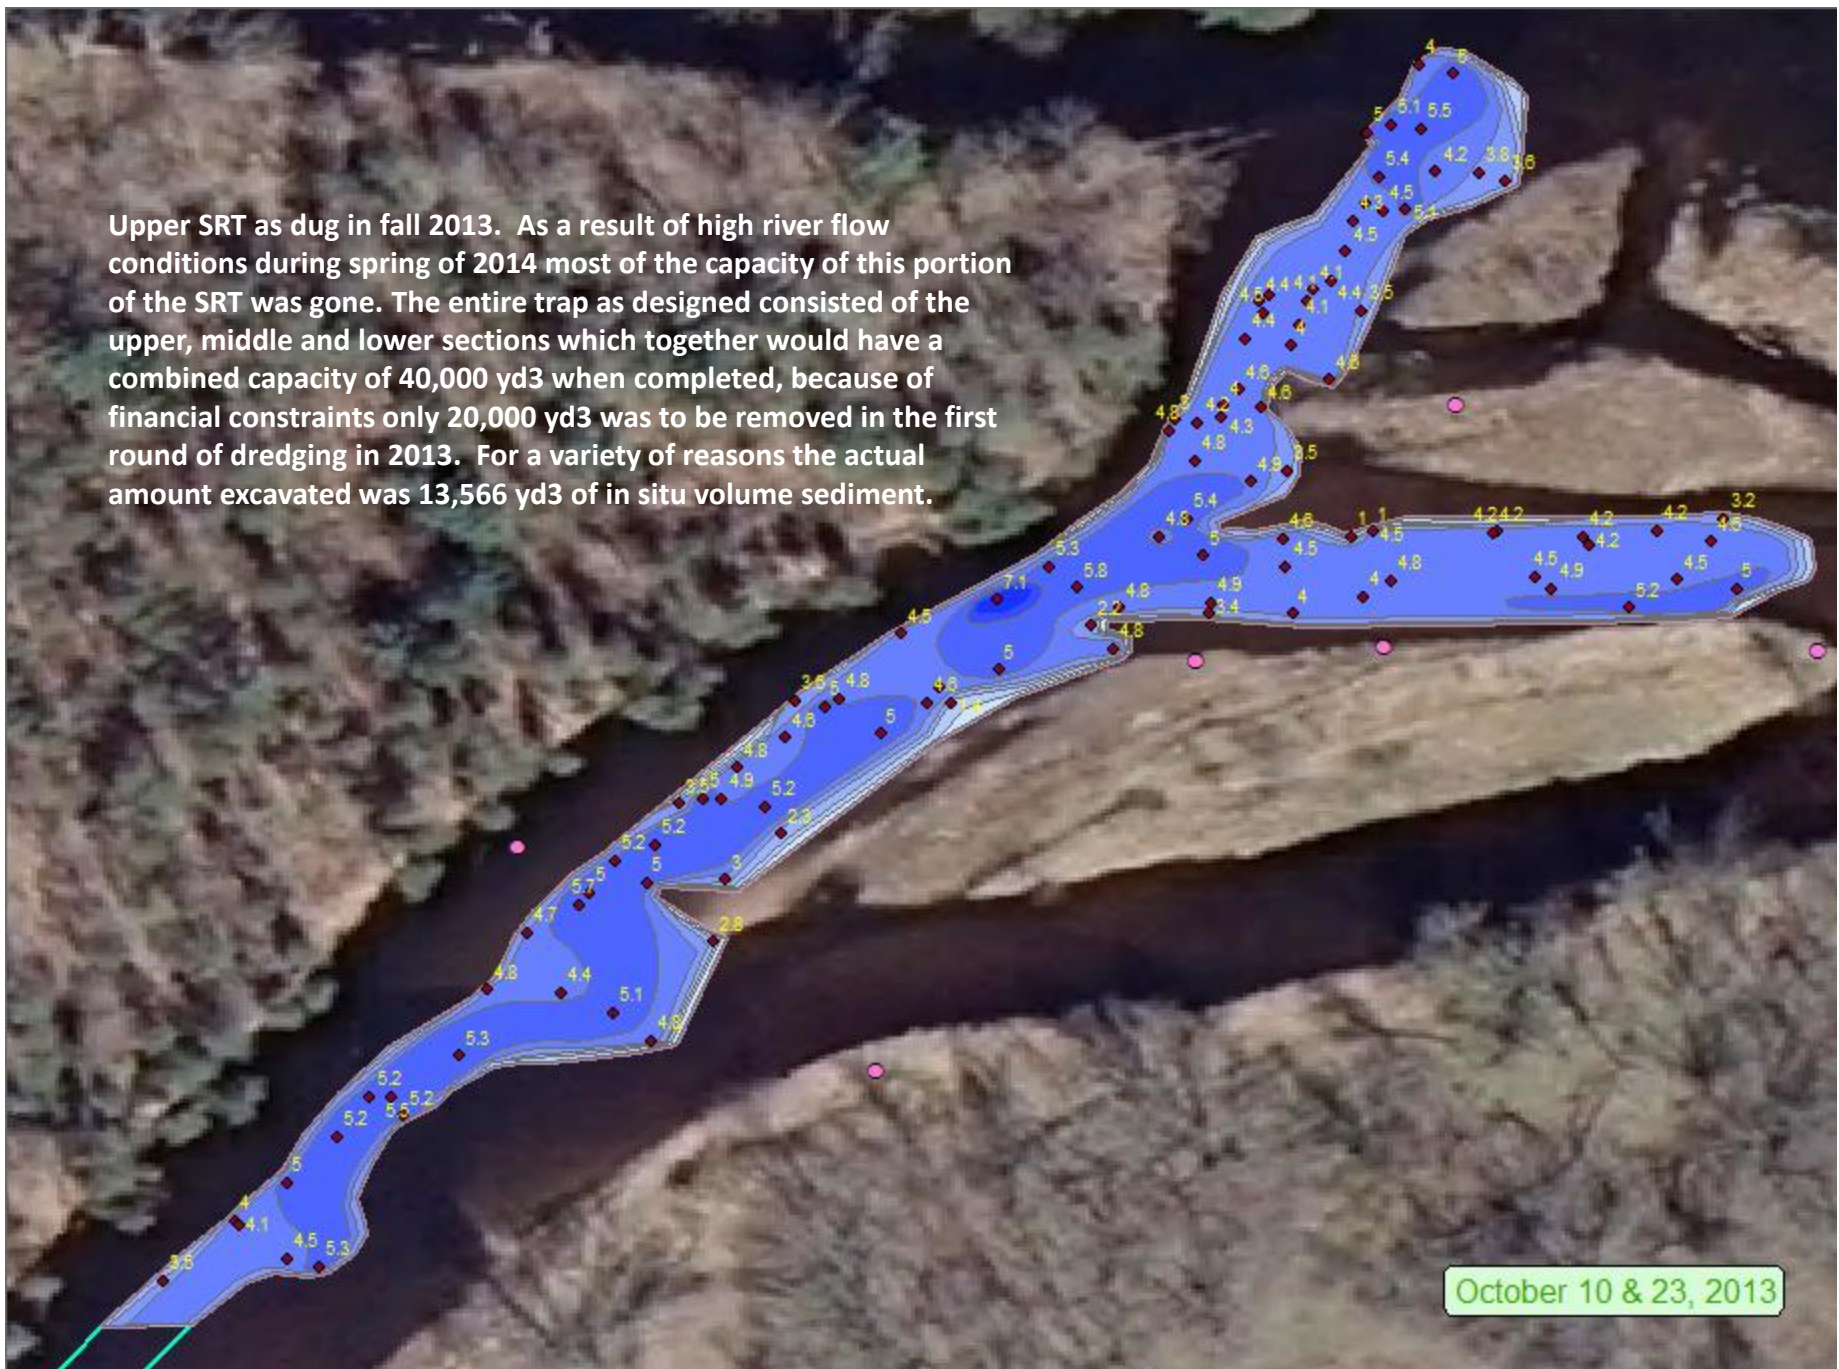
Upper SRT as dug in fall 2013. As a result of high river flow conditions during spring of 2014 most of the capacity of this portion of the SRT was gone. The entire trap as designed consisted of the upper, middle and lower sections which together would have a combined capacity of 40,000 yd³ when completed, because of financial constraints only 20,000 yd³ was to be removed in the first round of dredging in 2013. For a variety of reasons the actual amount excavated was 13,566 yd³ of in situ volume sediment.

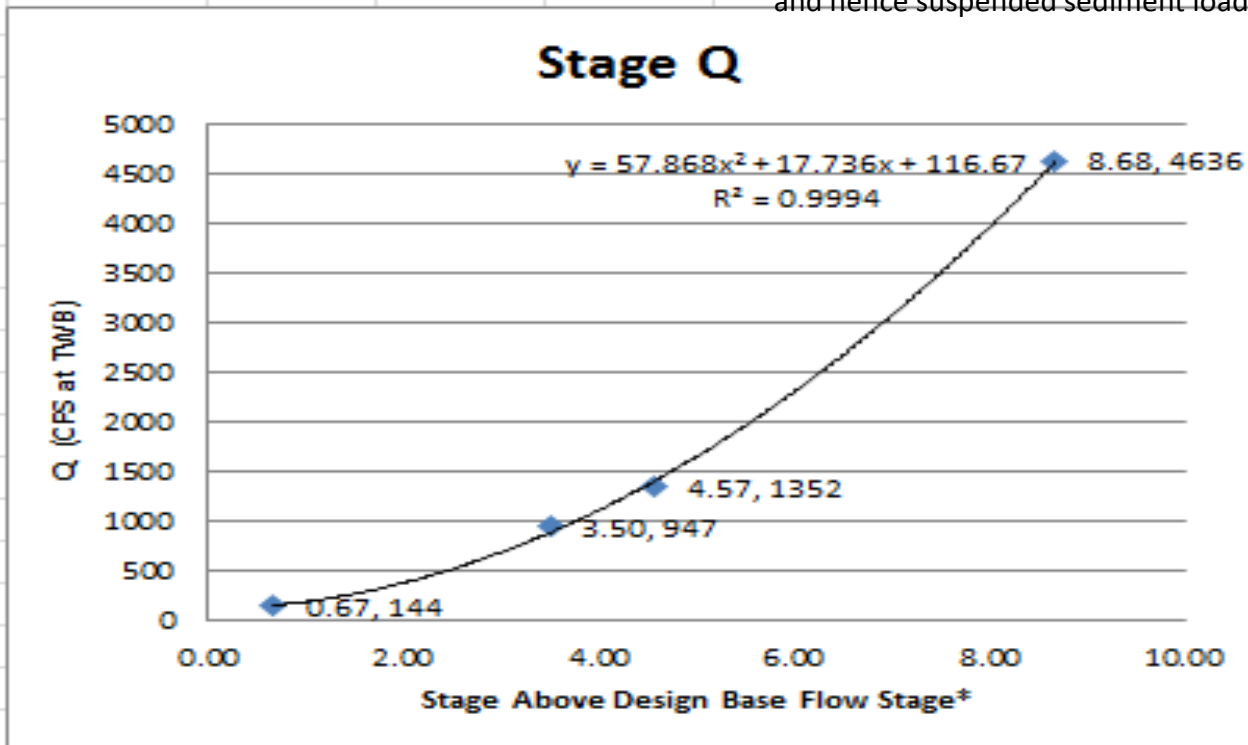
Since the last LECMP a stage gauge has been installed and is being monitored by GOES. The stage gauge readings were calibrated to produce a measure of flow vs stage height that is shown in the above figure. It is important that this station continue to be maintained and monitored and further calibrated with sediment transport. This establishes the relationship between precipitation levels and sediment transport towards LEC. Also because these flow meter calibrations were completed before complete bottom scouring occurred the calibration should be repeated soon. Recommendation calls for the replacement of current pressure sensor with an atmospheric vented pressure sensor that reports telemetry data daily. A sensor package is available that can also simultaneously measure turbidity and hence suspended sediment load.

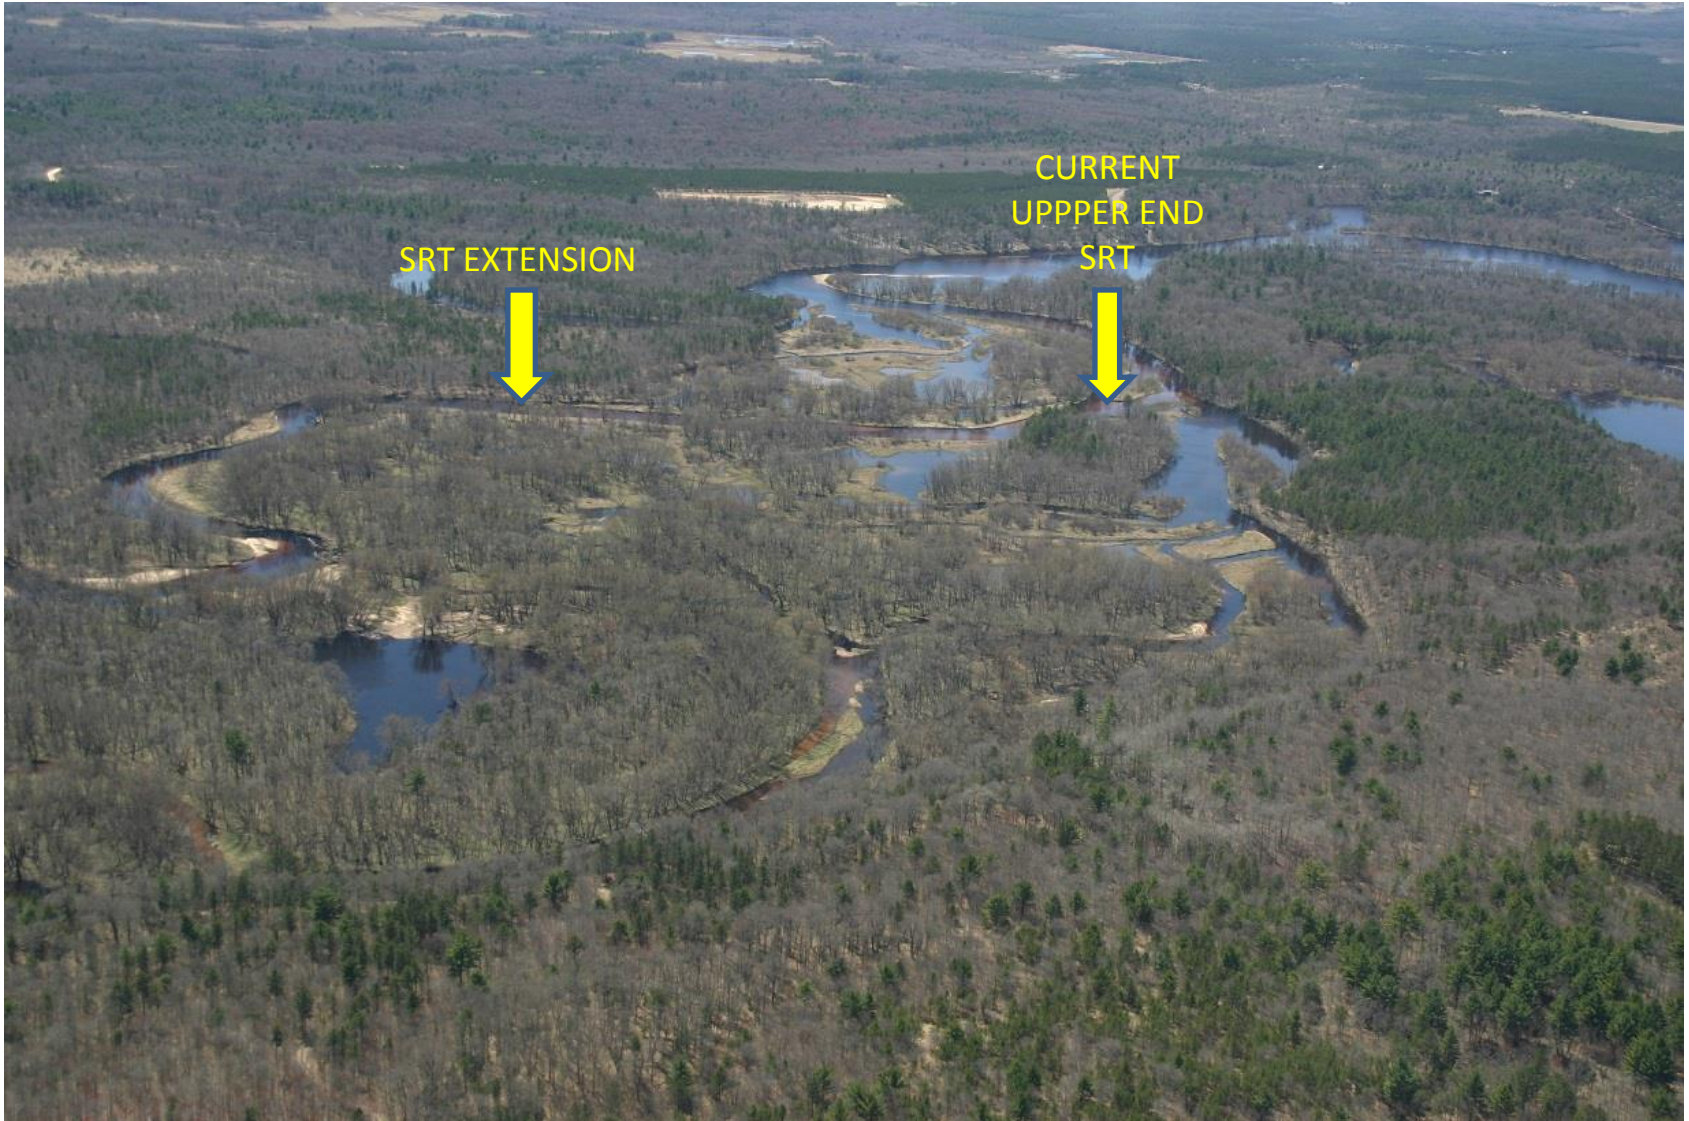
PRELIMINARY DESIGN PLAN FOR SKID ROW EXTENSION TRAP AND NEW SEDIMENT SPOILS AREA

A new extension of the existing Upper SRT is proposed and is referred to as the SRT Extension. Its location is shown in the following figures as is a newly proposed spoils area that would serve to retain dredge spoils from local sediment traps

SRT EXTENSION

CURRENT
UPPPER END
SRT

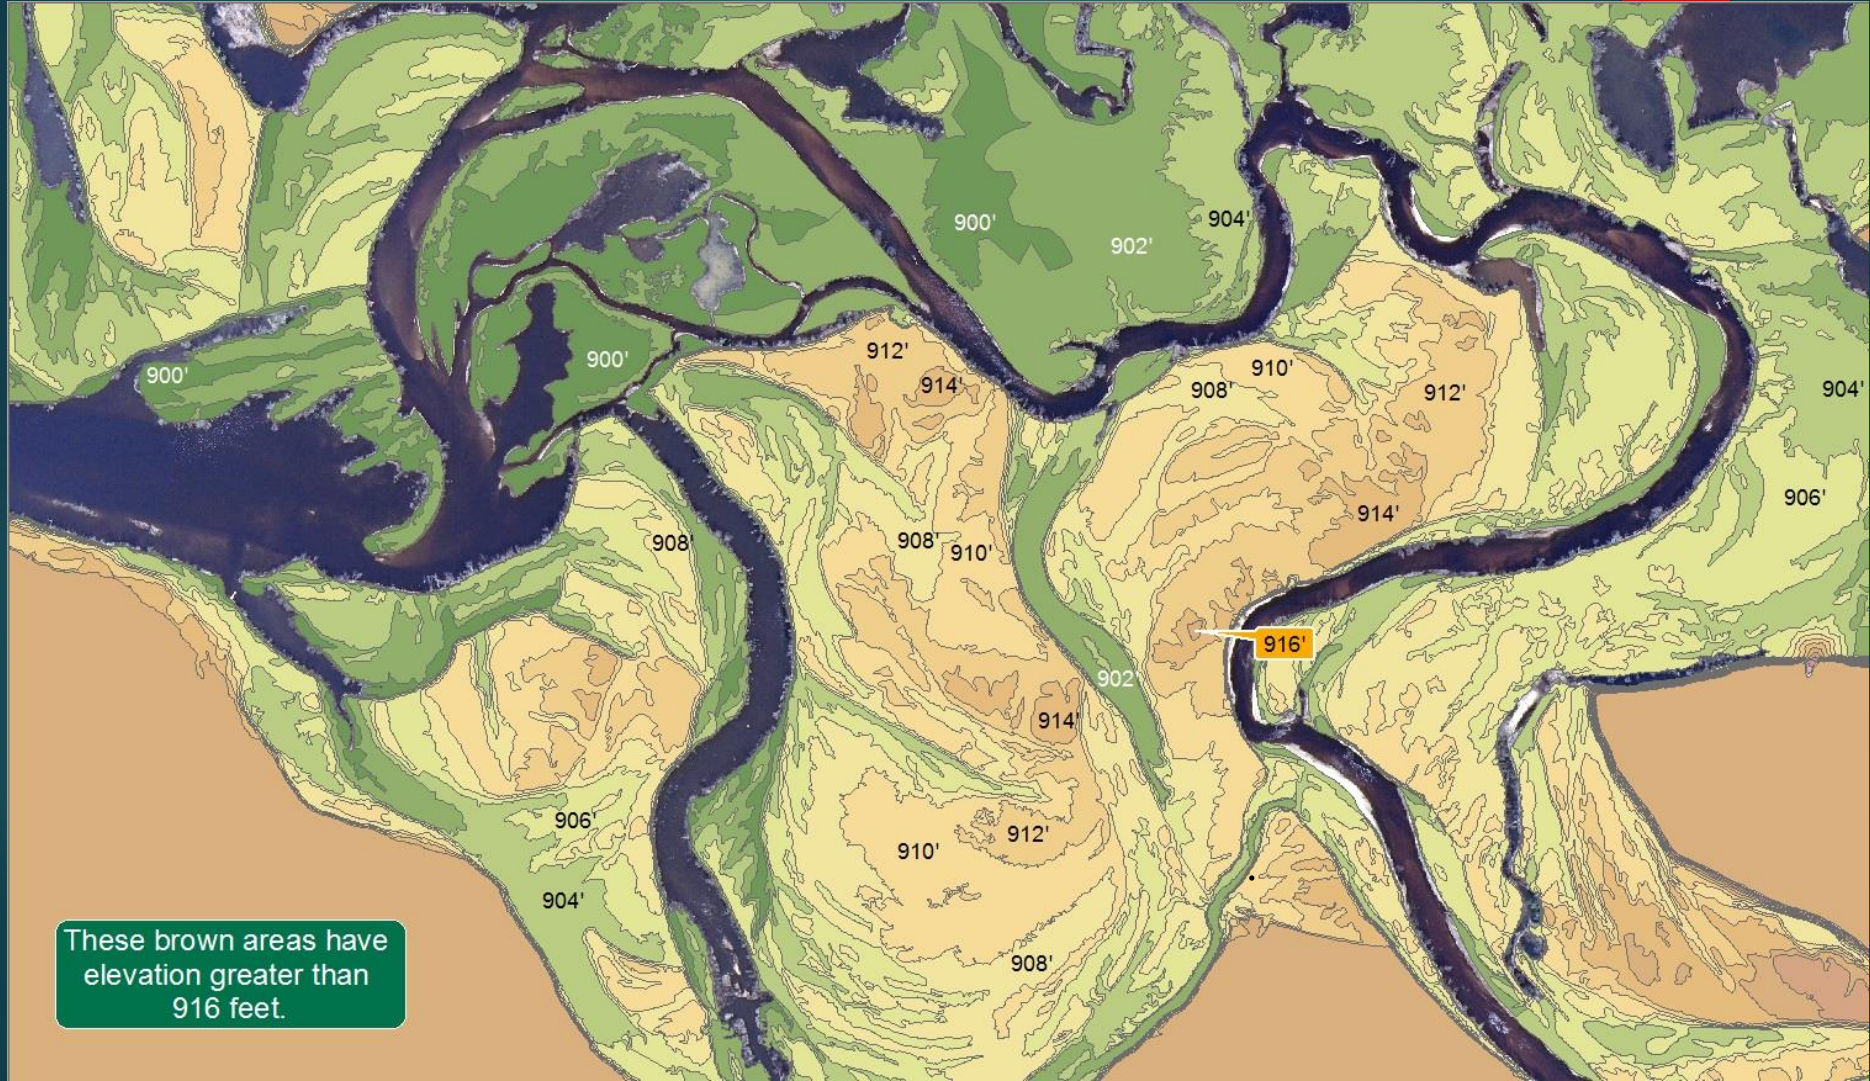
Lidar image from 2013 showing elevations of the GPT and SRT flood plain regions.
